Canon MP730 Printer Purge Unit Disassembly and Assembly

By G. Patton

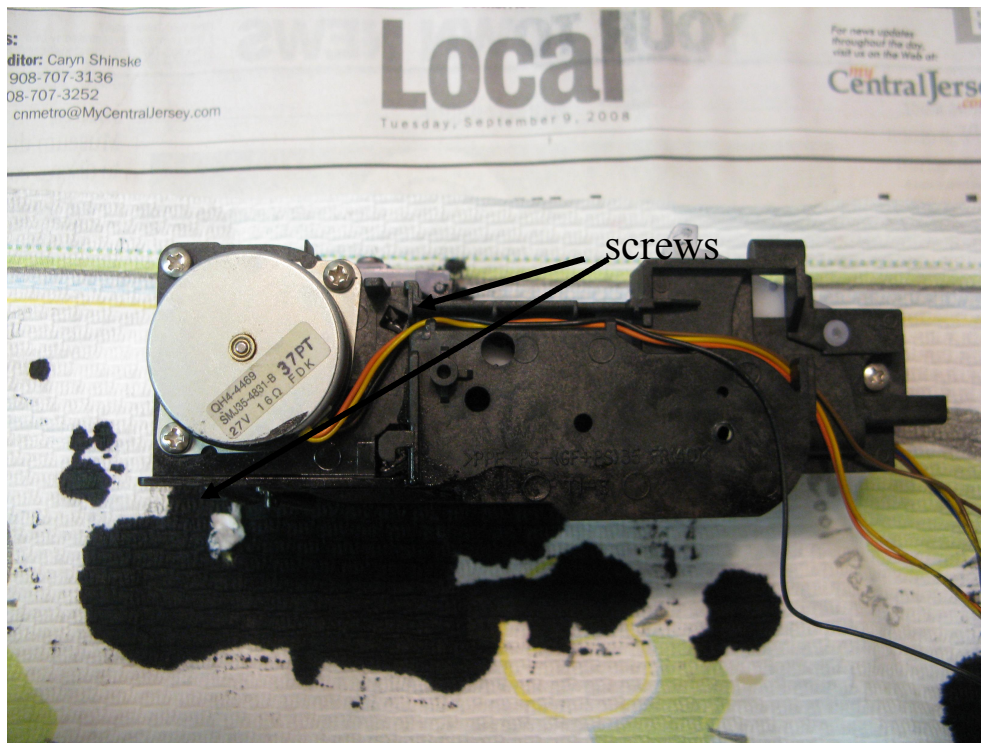
To take apart the purge unit you first unthread the wires from the motor through the case. Then take off the motor by unscrewing two screws Figure 1.

Figure 1 – Screws to take off motor

Set the screws and the motor aside in a cup for later assembly. At this point you could probably wash the purge unit in water and get most of the ink out and not take it apart further. We really just didn't want to get the motor wet. However, it is easy to go a little further.

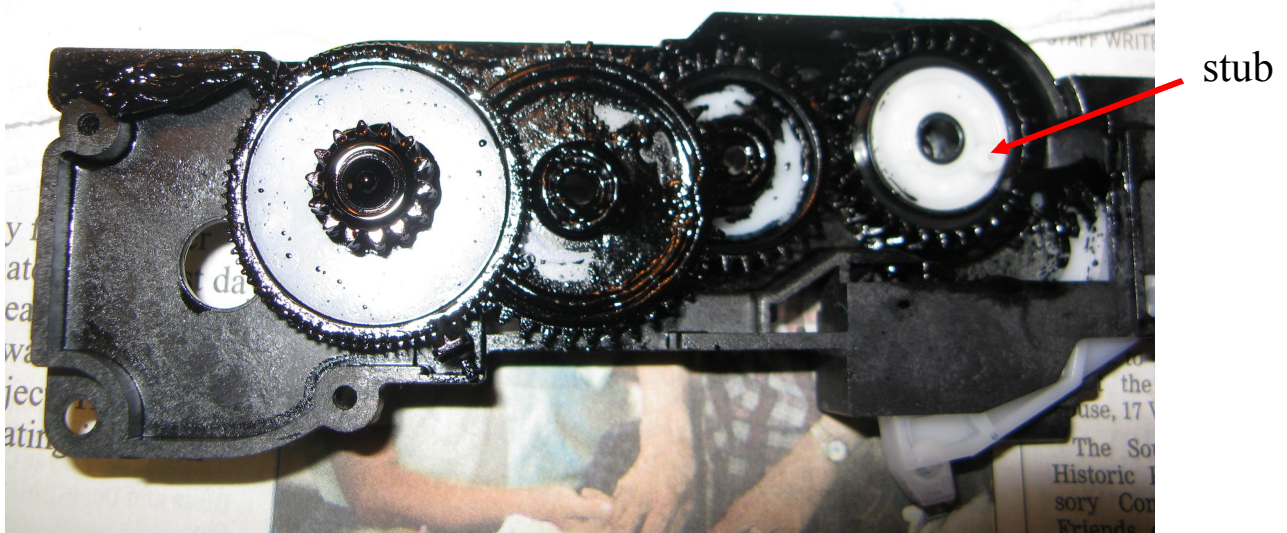
Take off the right side of the purge (as you look at it from the motor end). There are again 2 screws. It should come off fairly easily with all the gears in it intact. Also no pieces should fall off from the inside. The flipped off right side should look like Figure 2 but without all the ink.

Figure 2 – Right side of purge unit flipped over

Note the big gear on the left has small teeth and is fastened to the case, the others have larger teeth on the outer rim. The gear on the right has a black rim and a stub protruding up from it. This engages in the black gear on a unit in the other half as we will see later.

2. Put on the right side. This is tricky. First I rotated the gears in the right side so the stub on the gear on the right would fit into the hole in the black gear. Then I flipped the right side over and put it on making sure the black gear's end point went in the hole in the case and that the stub on the white gear went in the black gear's hole. At the same time I slightly turned the gear on the left so it meshed with the gear on the mechanism which turns and creates the suction. Also I held the locking pin down and made sure its spring was seated. Thus there are four things that have to be done at once. If everything meshes the right side will fit flat on the case and you can put in the two screws. If you have done it correctly 1) the locking pin will not be so tight it won't move up and down easily, 2) turning the large gear whose teeth show just inside the right cover clockwise will cause the suction assembly to go up and down and the wiper to go back and forth. Note it takes a little pressure on the gear to make these things happen but don't break the gear teeth. This is probably the trickiest part of the whole job. Note that the suction assembly won't go down if the purge unit is sitting on a table since the suction tubes come below the case when the unit is down. Figure 6

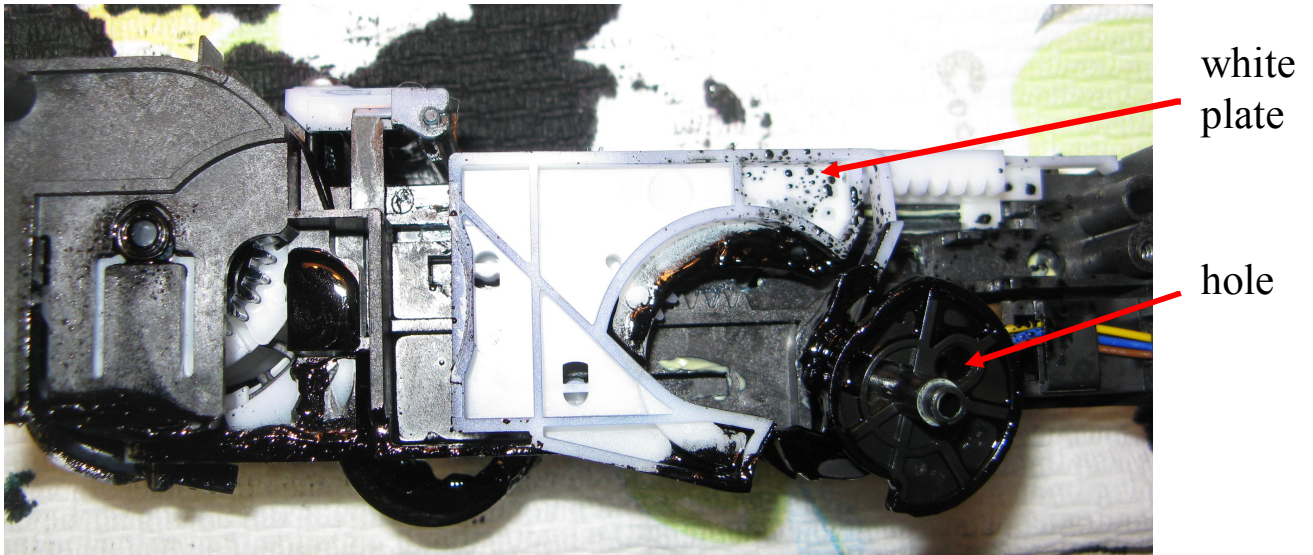
The purge unit with the right side off is shown in Figure 3. The top in the picture is really the right side.

Figure 3 – Right side of purge unit

The large white plate in the center slides left and right moving the wiper blades to clean the print head. The black solid looking gear on the right is the key to all the movements. It has a hole in it where the stub poking up from the gear in Figure 2 goes when the right side is closed. The gear also has a catch that hooks onto the white plate. Turning the black gear, very carefully and it is pretty hard to turn, causes the purge unit vacuum head to move up and down. It also causes the print head carrier lock (which is in the piece with the gears), to be locked and covered or unlocked and uncovered for printing. I took the white plate off by unhooking it from the black gear and sliding it to the left where there is a notch in the frame where a bottom hook can be pulled through. Then with it just pulled through it can slide away from you to unhook two other hooks that hold it to the frame. You should see a white gear that sits under the plate Figure 4.

Probably if I were a repair person I would put some proper grease on the sliding parts of the unit and the gears here. Canon suggests you use a special grease. I didn't use any but you will note there was some of the original grease left even after cleaning. When putting the white plate on I turned the black gear so the hook was in the upper left quadrant and the white plate just hooked into it as when I took it apart as in figure 3.

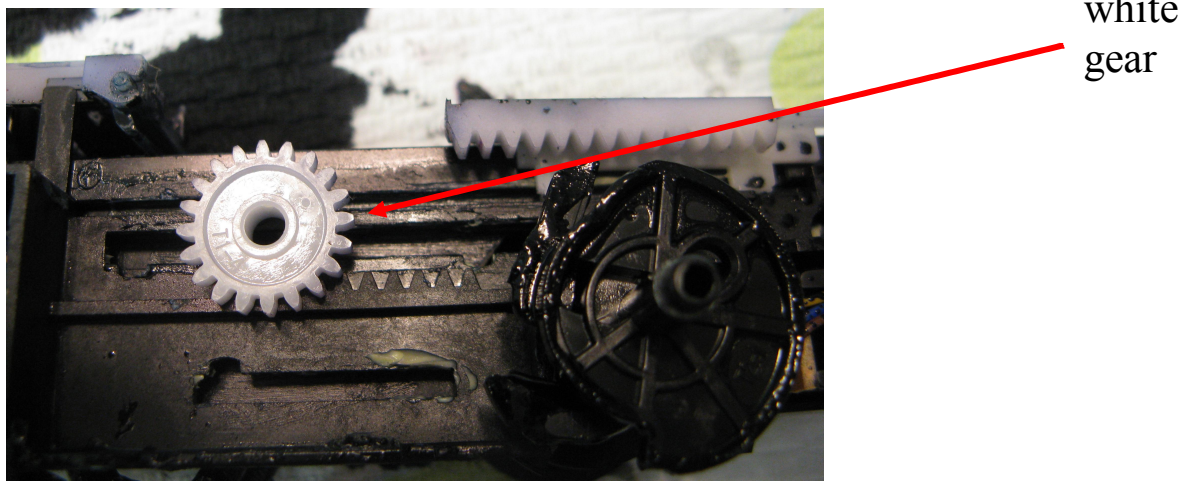
Figure 4 – Position of white gear

You can take out the white gear and put it in a cup with the white plate. At this point I felt I could pretty much see everything so I stopped taking things apart and washed everything in water. Of course you don't want to wash anything down the drain, like a spring or a gear but surprisingly everything pretty much stayed together. The one part I was a little careful of was the sensor unit with the wires coming from it. Since the Canon ink is conductive you don't want to leave any ink between any connections that could short the printer. Thus don't get ink on the connections while washing and if you do rinse it off thoroughly.

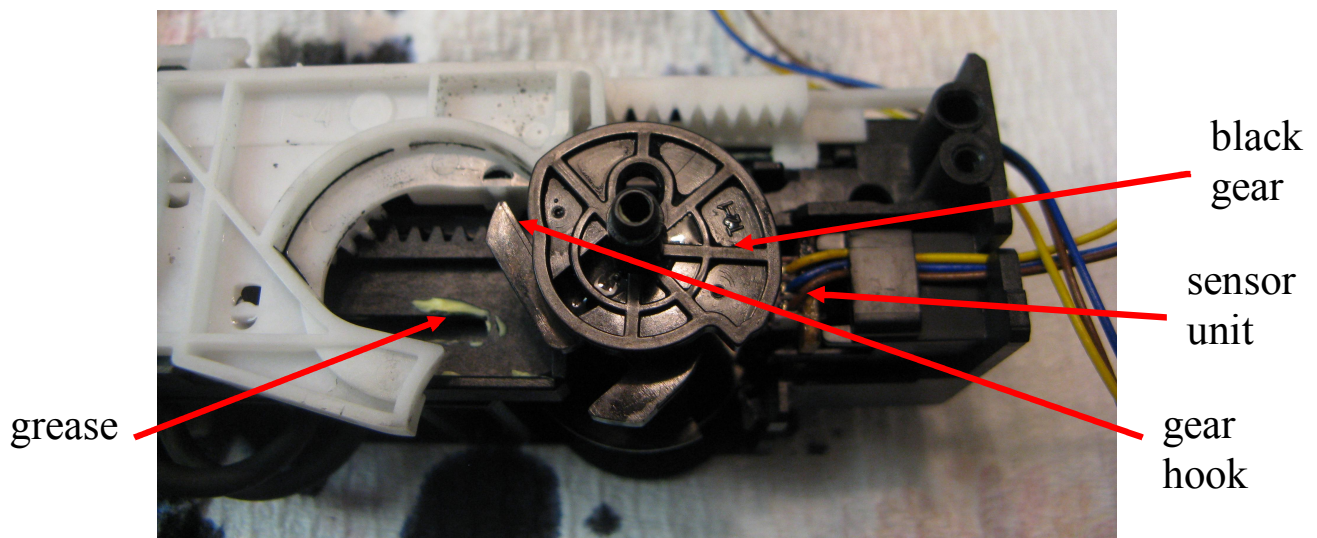
Figure 5 – A cleaned up white plate and black gear

1. Put on the white plate – First put in the white gear and position it so the white plate stub goes into the hole in the gear. Position the plate so the hooks on the top of the plate are over the frame it slides on and then put the lower hook through the hole in the frame and slide the unit right. I slid it over until it hooked on the black gear as it was in the beginning. There is probably an official procedure for this but I don't know it.

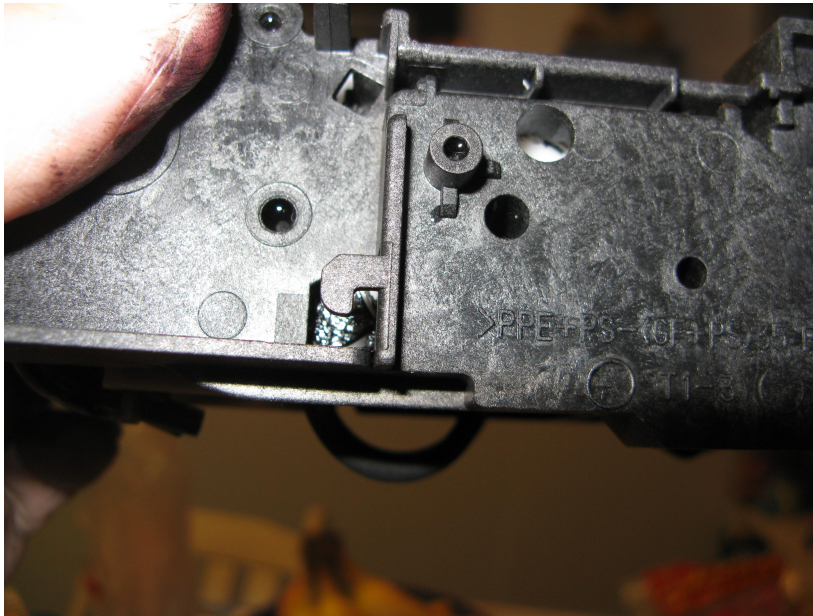
Figure 6 – Suction tubes hanging down

If the suction unit is not all the way down the wiper will hit it and damage the wiper. So when testing, hold the unit in your hand with nothing under the bottom as you turn the gear.

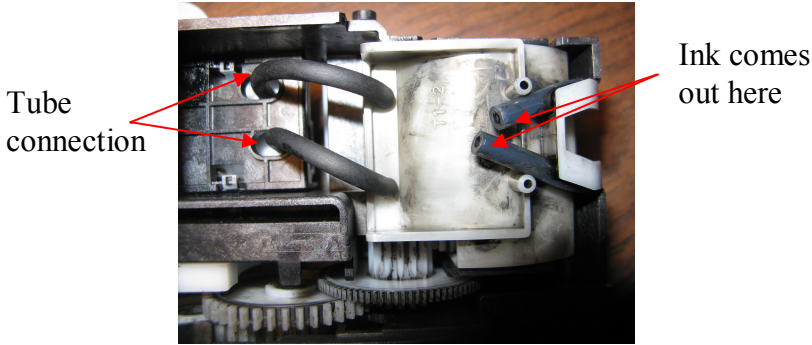
Tube connection

Ink comes out here

Figure 7-a – Bottom of purge unit with tubes

There should be two tube ends and two tubes curving down with the left end connected to the bottom of the suction area.

Also at this point check that the rubber tubes coming from the plastic nipples of the suction area are connected and that they didn't come detached in the cleaning. If they did come detached there will be no suction in the suction area and no ink coming to the print head via suction. The bottom of the purge unit should look like Figure 7.

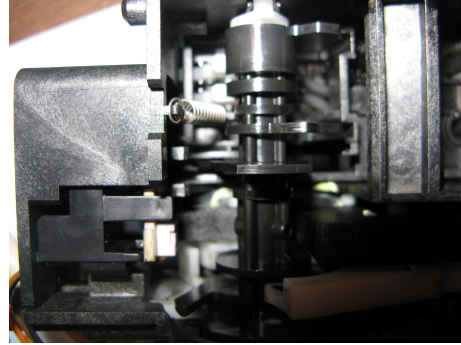
Figure 7-b bottom of purge unit gears

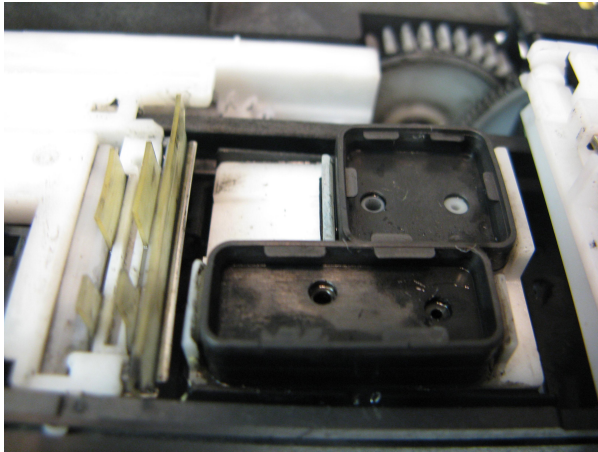
Figure 8– Suction holes exposed wiper on left
Suction units are up

Figures 8 and 9 are looking from the left (other side) of the purge unit and show the suction and wiper units after cleaning. Usually there are ceramic pads over the holes. When the suction units are up it protects the print head holes and keeps the print head from drying out. When it is down the wiper can wipe over the head taking off extra ink and then the print head can move across the paper and print the page.

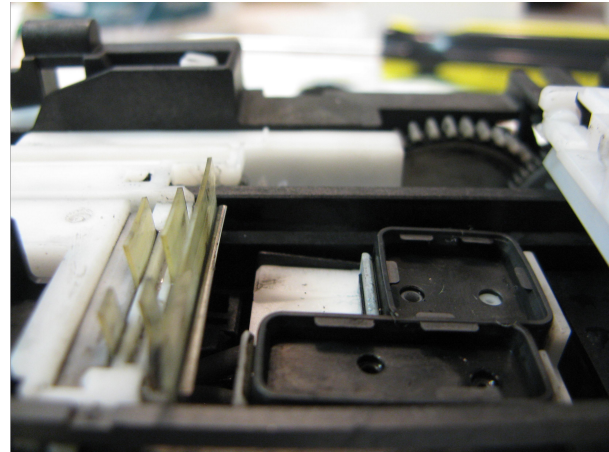
Figure 9 – Suction holes exposed
suction units are down

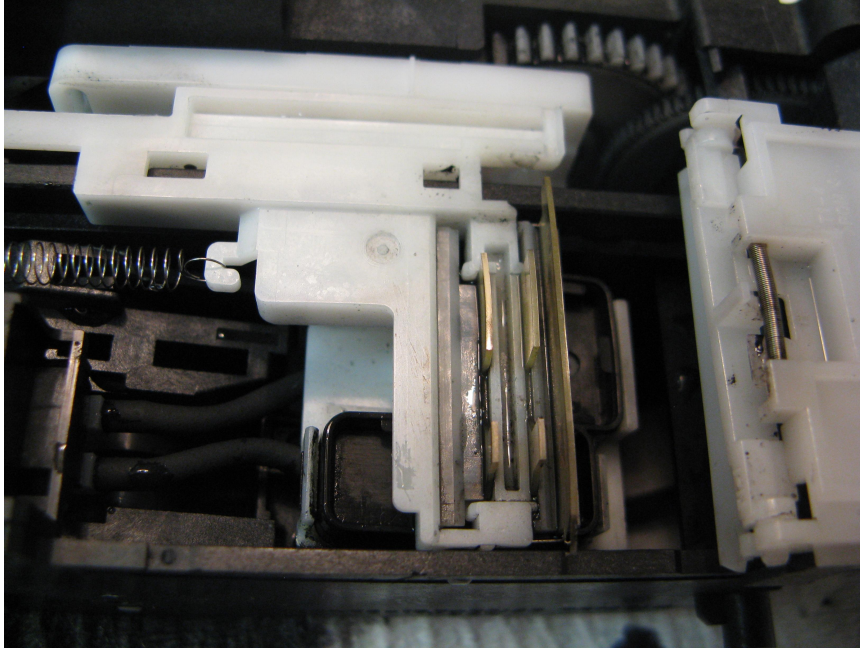
Figure 10 – During the wiping process

Figure 10 shows the wipers in action moving from left to right over the suction unit which has dropped down. Note there is a wiper to wipe the wiping unit on the right and the wiping unit should move far enough to get wiped by the unit on the right. Figure 10 is also looking from the left side of the purge unit.
